**SAS Superstructure**

Location: 04-SF-80-13.2 / 13.9

**Daily Diary Report by Bid Item**

Diary #: 820 Const Calendar Day: 308 Date: 08-Apr-2013 Monday

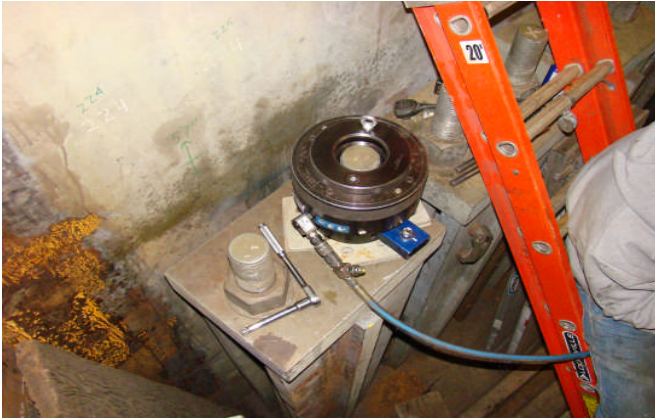
ABF ironworkers then received two new jack bridge/gearboxes and proceeded to stress anchor rods b1(E)11 and 12. After spending a considerable amount of time and effort trying to fix the threads on rod 11, the decision was made to use shims to account for the difference between the jack puller and tensioner. See photos below for more details on this setup. Due to the shim setup both rods were stressed independently of each other. The first anchor rod to be stressed was b1(E)11 to ram pressure cycles of 5.0ksi, 9.0ksi, then to 13.3ksi. Similarly pressure cycles for anchor rods b1(E)12 which was stressed for the first time were 5.8ksi, 11.3ksi, and 13.2ksi. Elongations for anchor rod 11 was 225-242 = 17mm, and for rod 12 the change in length was from 224-242 = 18mm. Both rods were then tested together in series before the jacks were removed.

Shims placed underneath the bridge/gearbox to enable anchor rod b1(E)11 to be stressed.

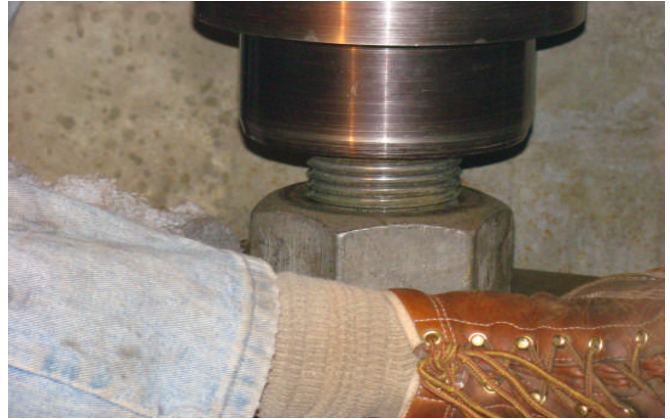
Gap between the jack puller and the anchor rod nut which needs to be bridged in order to stress the rod.
